Flood Control Project Maintenance
2019 Structure Summary Report
Overall Unit and Item Ratings

Lower San Joaquin Levee District

Ash Slough Drop Structure No. 1

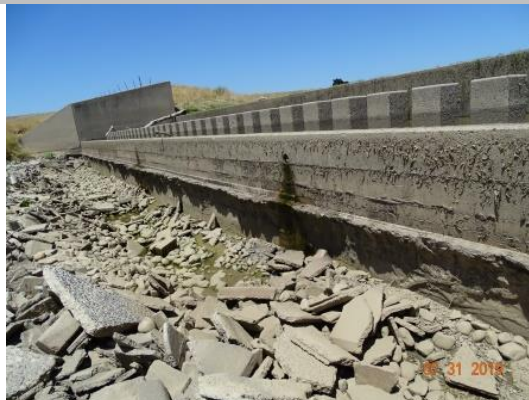
Photo 1 of 3 : ST_2019_NA0010_24_4_20190807_00021.jpg

LM Start	0.00	Rating **	M	Issue No.	4
LM End	0.00	Issue Type +	Ma	Location *	
Category	Structures & Concrete Lined Channels	GPS Latitude/Longitude			
		Start		End	
Item	Erosion / Bank Caving	37.033952 °		37.033952 °	
		-120.441733 °		-120.441733 °	
DWR ID	DWR_NA0010_24_t_2017_4				
Action/Comments					
Inspector Comments: Some minor erosion or animal burrowing was found on the back side of the right wing wall of the structure. Rock along the downstream edge of the structure has been washed away.

Erosion at the downstream side of the structure. (2019)

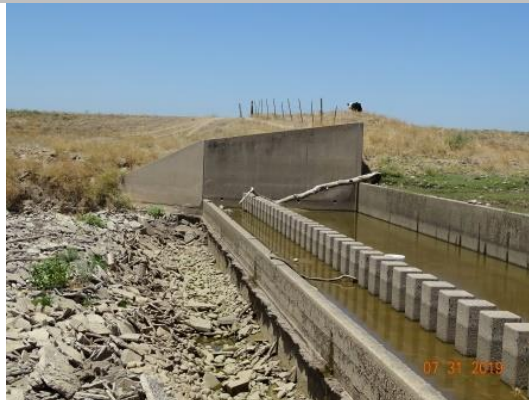
Photo 1 of 3 : ST_2019_NA0010_24_5_20190807_00017.jpg

LM Start	0.00	Rating **	U	Issue No.	5
LM End	0.00	Issue Type +	Ma	Location *	
Category	Structures & Concrete Lined Channels			GPS Latitude/Longitude	
				Start	End
Item	Revetments			37.033952 °	37.033952 °
				-120.441733 °	-120.441733 °
DWR ID	DWR_NA0010_24_t_2012_5				
Action/Comments					
Inspector Comments: Downstream revetment has been washed away from the structure and should be replaced.

Downstream revetment has been washed away. (2019)

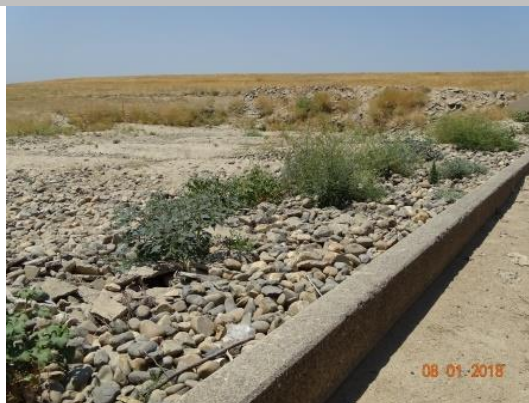
Photo 3 of 3 : ST_2019_NA0010_24_5_20190613_00008.jpg

View of downstream revetment that was placed after 2017's inspection (2018)

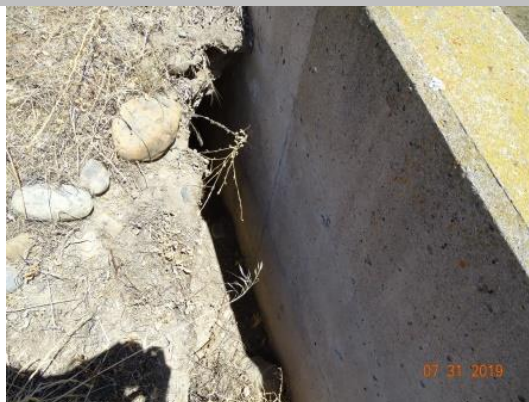
Photo 1 of 3 : ST_2019_NA0010_25_4_20190807_00018.jpg

LM Start	0.00	Rating **	M	Issue No.	4
LM End	0.00	Issue Type +	Ma	Location *	
Category	Structures & Concrete Lined Channels			GPS Latitude/Longitude	
				Start	End
Item	Erosion / Bank Caving			37.037853 °	37.037853 °
				-120.440067 °	-120.440067 °
DWR ID	DWR_NA0010_25_t_2012_4				
Action/Comments					
Inspector Comments: Large hole on the exterior of the right side wall 2-3 feet wide and 4-5 feet deep and 6-8 feet long. This erosion extends back to the headwall which is visible.

Erosion at right sidewall (2019)

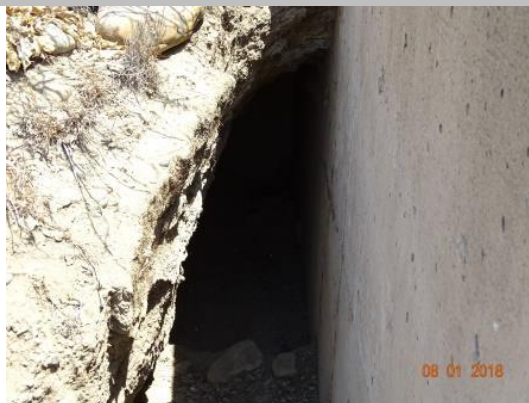
Photo 2 of 3 : ST_2019_NA0010_25_4_20190613_00005.jpg

Erosion at right sidewall (2018)

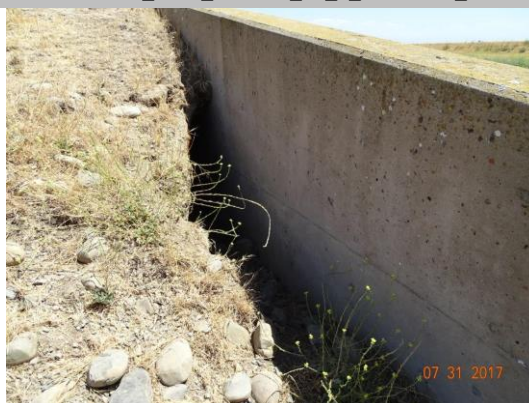
Photo 3 of 3 : ST_2019_NA0010_25_4_20190613_00006.jpg

Erosion on the right sidewall (2017)

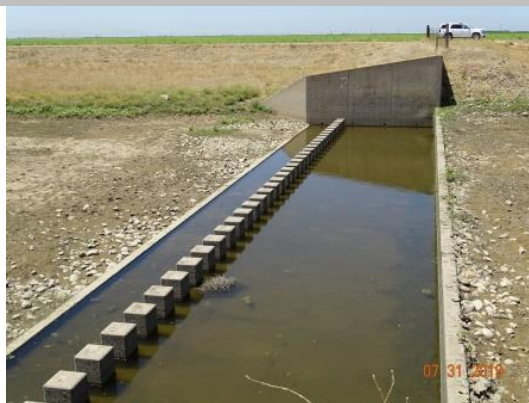
Photo 1 of 2 : ST_2019_NA0010_25_5_20190807_00019.jpg

LM Start	0.00	Rating **	A	Issue No.	5
LM End	0.00	Issue Type +	Ma	Location *	
Category	Structures & Concrete Lined Channels			GPS Latitude/Longitude	
				Start	End
Item	Revetments			37.037853 °	37.037853 °
				-120.440067 °	-120.440067 °
DWR ID	DWR_NA0010_25_t_2012_5				
Action/Comments					
Inspector Comments: Existing revetment appears to be adequate, but is partially obscured by sand.

View of revetment looking towards right bank. (2019)

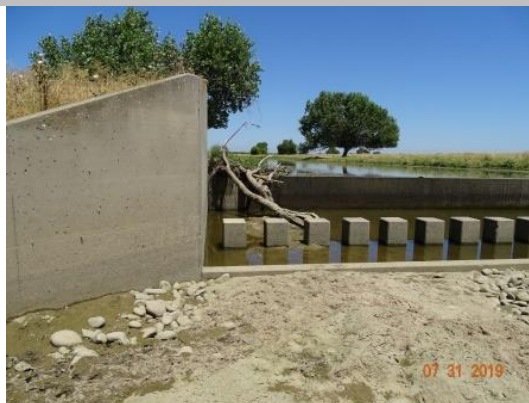
Photo 1 of 1 : ST_2019_NA0010_26_2_20190807_00016.jpg

LM Start	0.00	Rating **	A	Issue No.	2
LM End	0.00	Issue Type +	Ma	Location *	
Category	Structures & Concrete Lined Channels	GPS Latitude/Longitude			
		Start		End	
Item	Vegetation & Obstructions	37.042767 °		37.042767 °	
		-120.436323 °		-120.436323 °	
DWR ID	DWR_NA0010_26_t_2012_2				
Action/Comments					
Inspector Comments: Tree branch caught along right wing wall of structure.

Tree branches caught along right wing wall. (2019)

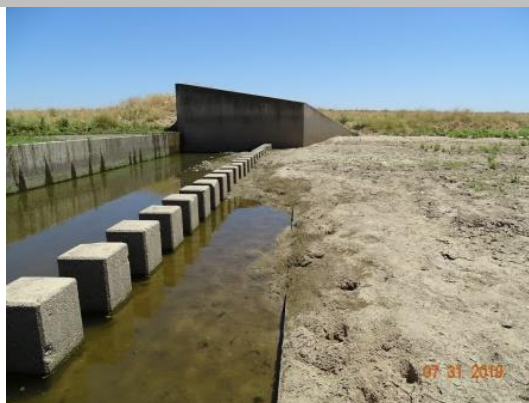
Photo 1 of 2 : ST_2019_NA0010_26_3_20190807_00017.jpg

LM Start	0.00	Rating **	M	Issue No.	3
LM End	0.00	Issue Type +	Ma	Location *	
Category	Structures & Concrete Lined Channels	GPS Latitude/Longitude			
		Start		End	
Item	Shoaling / Sedimentation	37.042767 °		37.042767 °	
		-120.436323 °		-120.436323 °	
DWR ID	DWR_NA0010_26_t_2012_3				
Action/Comments					
Inspector Comments: Sedimentation on the upstream side of structure and also on the downstream side of the left wingwall area.

Sedimentation near left wing wall. (2019)

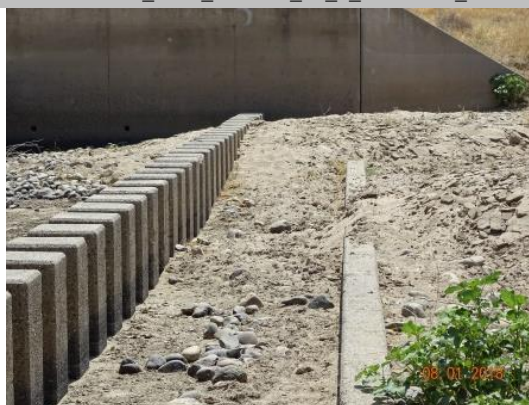
Photo 2 of 2 : ST_2019_NA0010_26_3_20190613_00004.jpg

Sedimentation near left wing wall (2018)

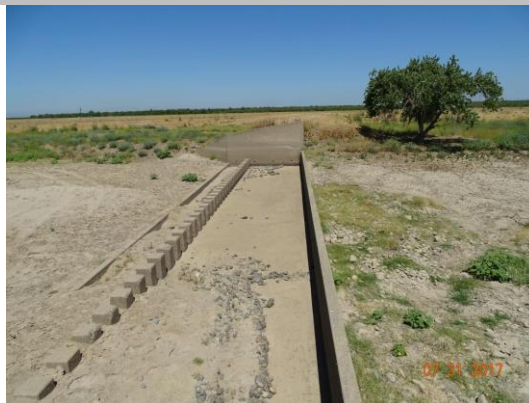
Photo 2 of 2 : ST_2019_NA0010_26_5_20190613_00008.jpg

LM Start	0.00	Rating **	A	Issue No.	5	
LM End	0.00	Issue Type +	Ma	Location *		
Category	Structures & Concrete Lined Channels			GPS Latitude/Longitude		
				Start		End
Item	Revetments			37.042767 °		37.042767 °
				-120.436323 °		-120.436323 °
DWR ID	DWR_NA0010_26_t_2012_5					
Action/Comments						
Inspector Comments: Existing revetment is covered by the sand. Recommend maintenance to ensure revetment is adequate.

Looking towards the right bank, the riprap is obscured by sedimentation and vegetation growth. (2017)

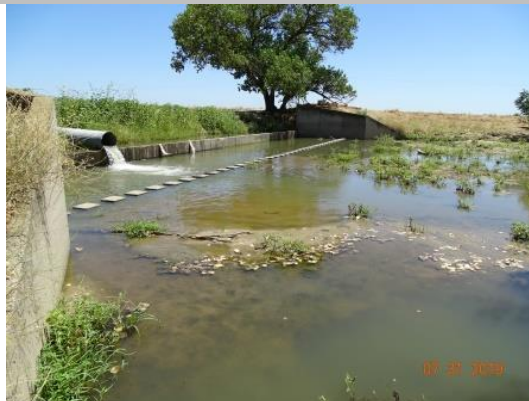
Photo 1 of 2 : ST_2019_NA0010_27_2_20190807_00025.jpg

LM Start	0.00	Rating **	M	Issue No.	2
LM End	0.00	Issue Type +	Ma	Location *	
Category	Structures & Concrete Lined Channels	GPS Latitude/Longitude			
		Start		End	
Item	Vegetation & Obstructions	37.045045 °		37.045045 °	
		-120.429855 °		-120.429855 °	
DWR ID	DWR_NA0010_27_t_2012_2				
Action/Comments					
Inspector Comments: Trees should be removed from around structure.

View of tree growing at the left head wall. (2019)

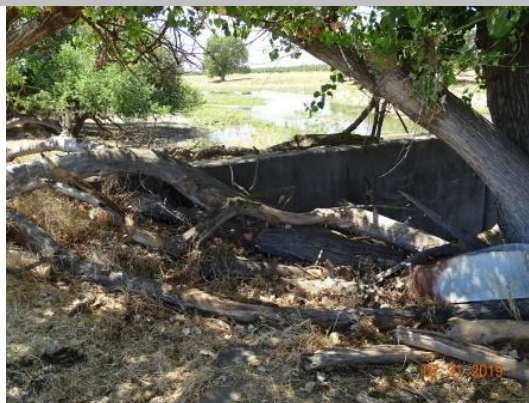
Photo 2 of 2 : ST_2019_NA0010_27_2_20190808_00029.jpg

Branches and debris piling up along left headwall. (2019)

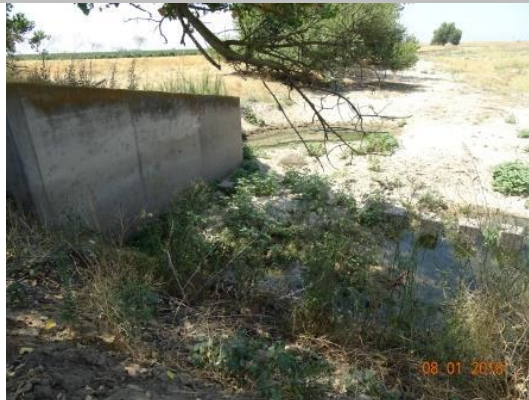
Photo 1 of 3 : ST_2019_NA0010_27_3_20190613_00007.jpg

LM Start	0.00	Rating **	A	Issue No.	3
LM End	0.00	Issue Type +	Ma	Location *	
Category	Structures & Concrete Lined Channels	GPS Latitude/Longitude			
		Start		End	
Item	Shoaling / Sedimentation	37.045045 °		37.045045 °	
		-120.429855 °		-120.429855 °	
DWR ID	DWR_NA0010_27_t_2012_3				
Action/Comments					
Inspector Comments: Minor sedimentation on the downstream left bank side of the structure and also the right bank side at the metal culvert outlet.

Sedimentation downstream along left wing wall. (2018)

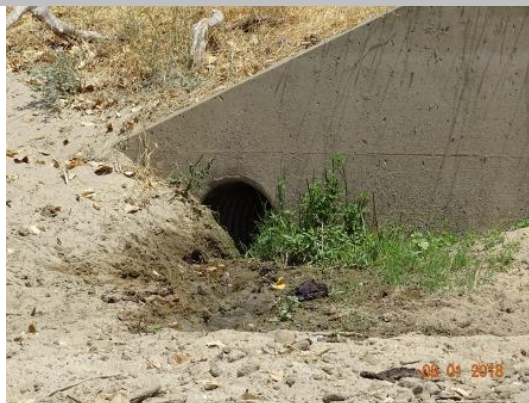
Photo 2 of 3 : ST_2019_NA0010_27_3_20190613_00008.jpg

Sedimentation along right wing wall near pipe outlet. (2018)

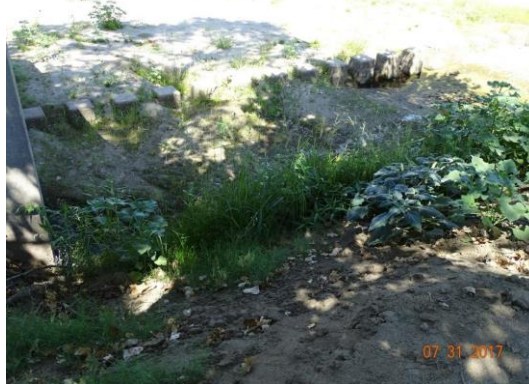
Photo 3 of 3 : ST_2019_NA0010_27_3_20190613_00009.jpg

View of sedimentation from the left bank looking to the downstream side of the structure. (2017)

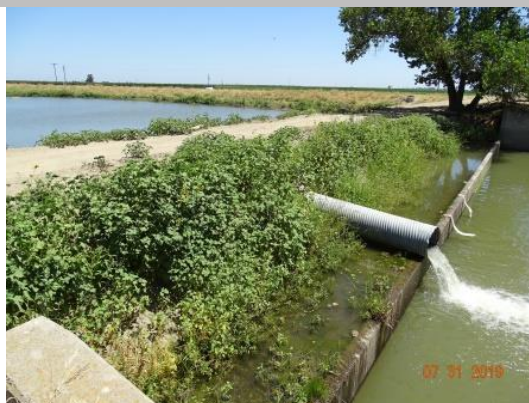
Photo 1 of 5 : ST_2019_NA0010_27_6_20190808_00026.jpg

LM Start	0.00	Rating **	U	Issue No.	6
LM End	0.00	Issue Type +	En	Location *	
Category	Structures & Concrete Lined Channels	GPS Latitude/Longitude			
		Start	End		
Item	Encroachments	37.045045 °		37.045045 °	
		-120.429855 °		-120.429855 °	
DWR ID	DWR_NA0010_27_t_2012_6				
Action/Comments					
Inspector Comments: Landowner is blocking the structure with a sand dam. Additionally, the landowner installed unauthorized pipes through the unauthorized sand dam.

View of unauthorized earthen dam and pipe from right bank. (2019)

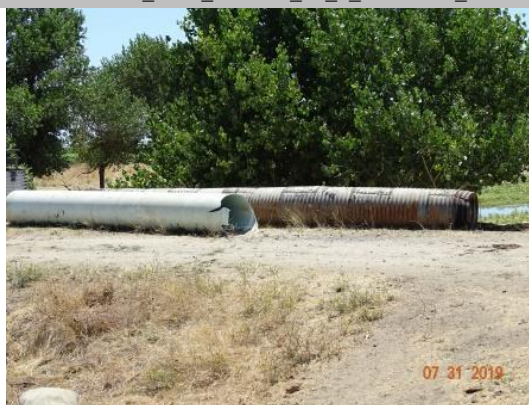
Photo 2 of 5 : ST_2019_NA0010_27_6_20190808_00027.jpg

Pipes stored on right bank of structure. (2019)

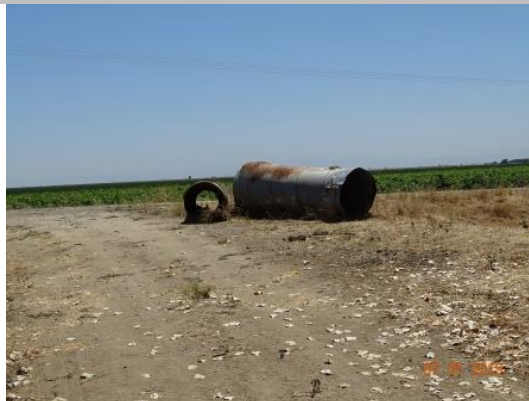
Photo 3 of 5 : ST_2019_NA0010_27_6_20190808_00028.jpg

Pipes stored on left bank of structure. (2019)

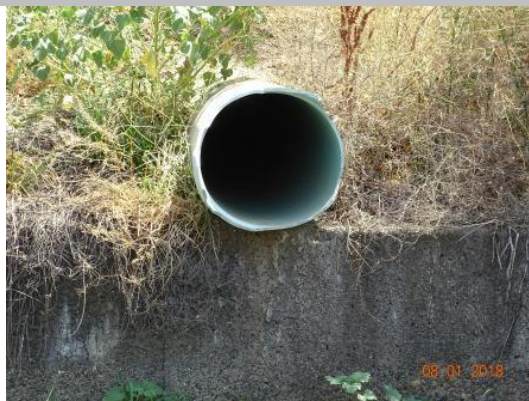
Photo 4 of 5 : ST_2019_NA0010_27_6_20190613_00013.jpg

LM Start	0.00	Rating **	U	Issue No.	6 (cont)
LM End	0.00	Issue Type +	En	Location *

View of the other unauthorized pipes through the unauthorized earthen dam. (2018)

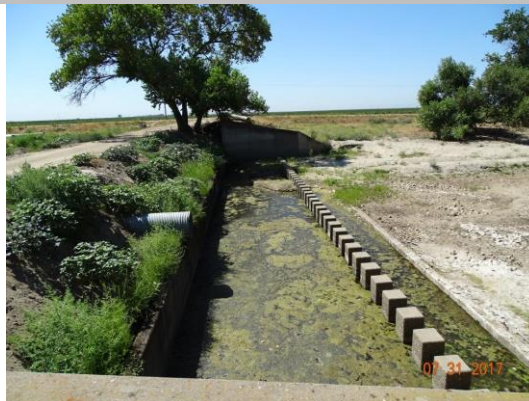
Photo 5 of 5 : ST_2019_NA0010_27_6_20190613_00014.jpg

LM Start	0.00	Rating **	U	Issue No.	6 (cont)
LM End	0.00	Issue Type +	En	Location *

Looking towards the left bank, the visible pipe is constructed through the sand dam. (2017)

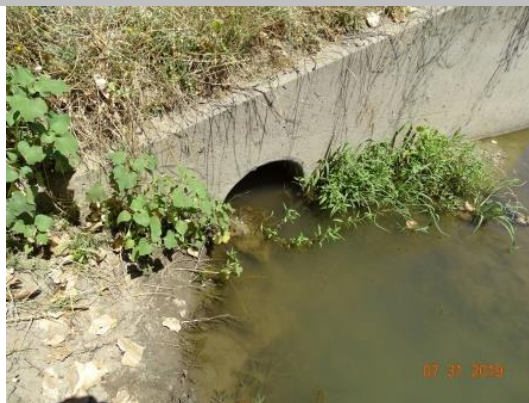
Photo 1 of 2 : ST_2019_NA0010_27_7_20190808_00030.jpg

LM Start	0.00	Rating **	A	Issue No.	7
LM End	0.00	Issue Type +	Ma	Location *	
Category	Structures & Concrete Lined Channels			GPS Latitude/Longitude	
				Start	End
Item	Culverts: Inlets / Outlets			37.045045 °	37.045045 °
				-120.429855 °	-120.429855 °
DWR ID	DWR_NA0010_27_t_2012_7				
Action/Comments					
Inspector Comments: The structure has 1 CMP culvert at the base of each wingwall that appear to be in good shape with no visible signs of deterioration.

View of culvert outlet at right wing wall. (2019)

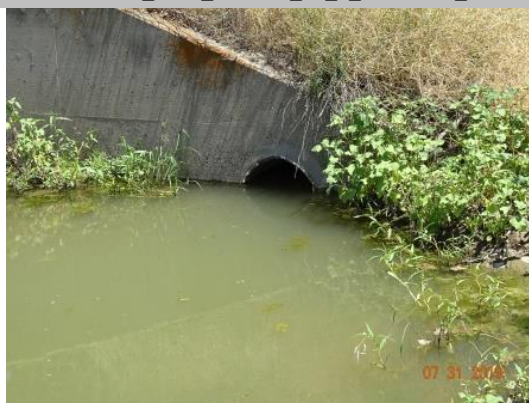
Photo 2 of 2 : ST_2019_NA0010_27_7_20190808_00031.jpg

View of culvert outlet at left wing wall. (2019)

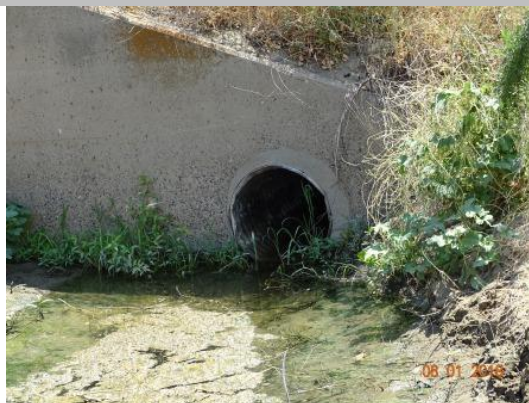
Photo 1 of 3 : ST_2019_NA0010_27_9_20190613_00017.jpg

LM Start	0.00	Rating **	A	Issue No.	9
LM End	0.00	Issue Type +	Ma	Location *	
Category	Structures & Concrete Lined Channels	GPS Latitude/Longitude			
		Start		End	
Item	Metal Pipes	37.045045°		37.045045°	
		-120.429855°		-120.429855°	
DWR ID	DWR_NA0010_27_t_2012_9				
Action/Comments					
Inspector Comments: The structure has 1 metal culvert at the base of each wing wall that appear to be in good shape with no visible signs of deterioration.

CMP in left wing wall downstream side. (2018)

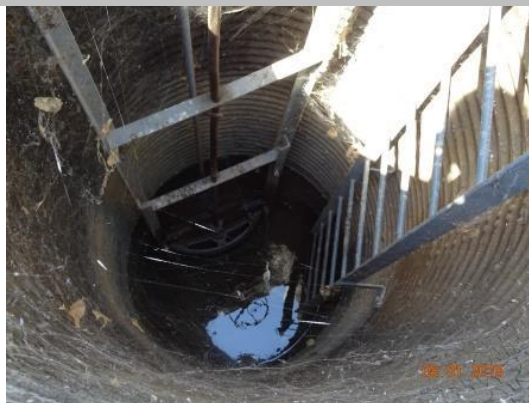
Photo 2 of 3 : ST_2019_NA0010_27_9_20190613_00018.jpg

Typical riser for CMP in structure. (2018)

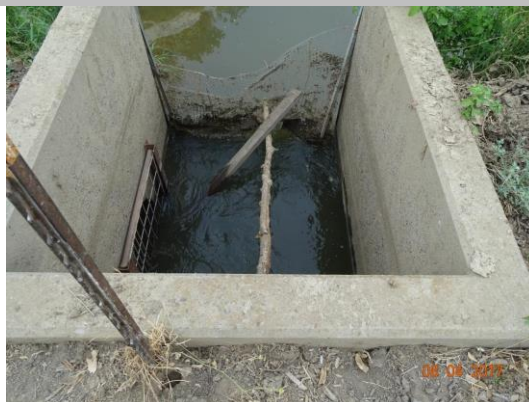
Photo 3 of 3 : ST_2019_NA0010_27_9_20190613_00019.jpg

Upstream, inlet for left wing wall CMP. (2017)

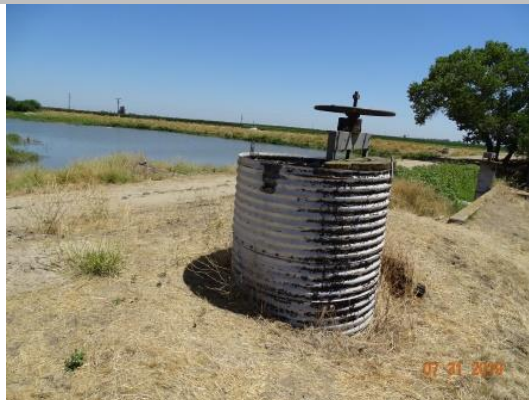
Photo 1 of 2 : ST_2019_NA0010_27_12_20190808_00032.jpg

LM Start	0.00	Rating **	A	Issue No.	12
LM End	0.00	Issue Type +	Ma	Location *	
Category	Structures & Concrete Lined Channels			GPS Latitude/Longitude	
				Start	End
Item	Sluice/Slide Gates			37.045045 °	37.045045 °
				-120.429855 °	-120.429855 °
DWR ID	DWR_NA0010_27_t_2012_12				
Action/Comments					
Inspector Comments: The structure includes 1 slide gate on each bank. Both are operational.

Slide gate on the right bank. (2019)

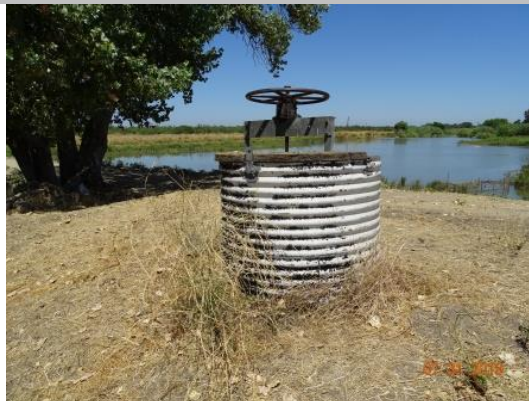
Photo 2 of 2 : ST_2019_NA0010_27_12_20190808_00033.jpg

LM Start	0.00	Rating **	A	Issue No.	12 (cont)
LM End	0.00	Issue Type +	Ma	Location *	
Category	Structures & Concrete Lined Channels			GPS Latitude/Longitude	
				Start	End
Item	Sluice/Slide Gates			37.045045 °	37.045045 °
				-120.429855 °	-120.429855 °
DWR ID	DWR_NA0010_27_t_2012_12				
Action/Comments					
Inspector Comments: The structure includes 1 slide gate on each bank. Both are operational.

Slide gate on the left bank. (2019)

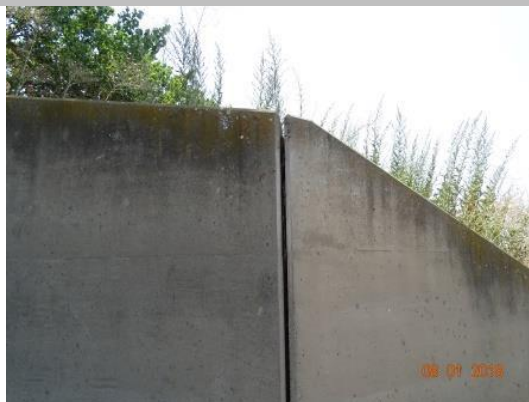
Photo 1 of 1 : ST_2019_NA0010_27_22_20190613_00022.jpg

LM Start	0.00	Rating **	M	Issue No.	22
LM End	0.00	Issue Type +	Ma	Location *	
Category	Structures & Concrete Lined Channels	GPS Latitude/Longitude			
		Start	End		
Item	Monolith Joints	37.045045 °		37.045045 °	
		-120.429855 °		-120.429855 °	
DWR ID	DWR_NA0010_27_t_2012_22				
Action/Comments					
Inspector Comments: The gasket on the right wingwall is starting to deteriorate. Recommend repair.

View of gasket on right wingwall. (2018)

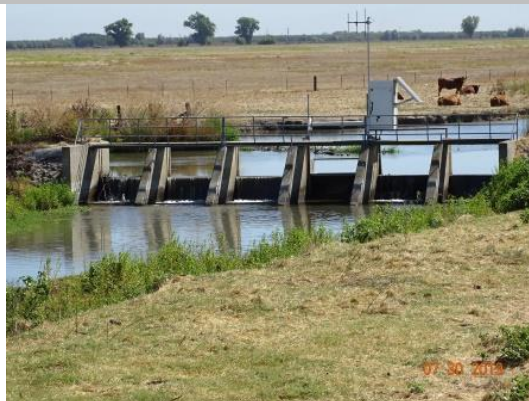
Photo 1 of 3 : ST_2019_NA0010_34_1_20190802_00018.jpg

LM Start	0.00	Rating **	N	Issue No.	1	
LM End	0.00	Issue Type +	Ma	Location *		
Category	Structures & Concrete Lined Channels			GPS Latitude/Longitude		
				Start		End
Item	Photo Documentation			37.254970 °		37.254970 °
				-120.718450 °		-120.718450 °
DWR ID	DWR_NA0010_34_t_2012_1					
Action/Comments						
Inspector Comments: Structure appears to be acceptably maintained.

Overview of structure from left bank looking upstream. (2019)

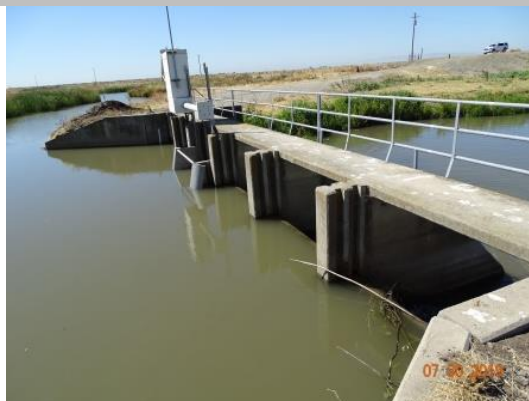
Photo 2 of 3 : ST_2019_NA0010_34_1_20190802_00020.jpg

View of upstream side of structure looking at the left bank. (2019)

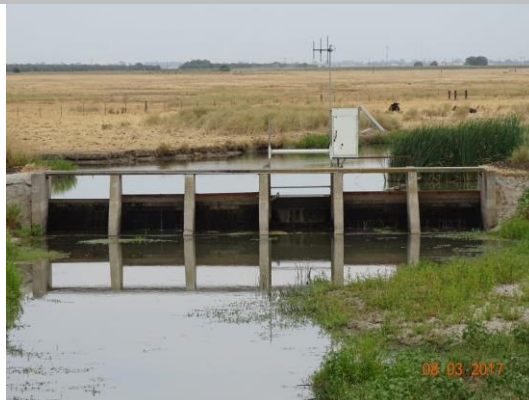
Photo 3 of 3 : ST_2019_NA0010_34_1_20190613_00003.jpg

View of downstream side of structure. (2017)

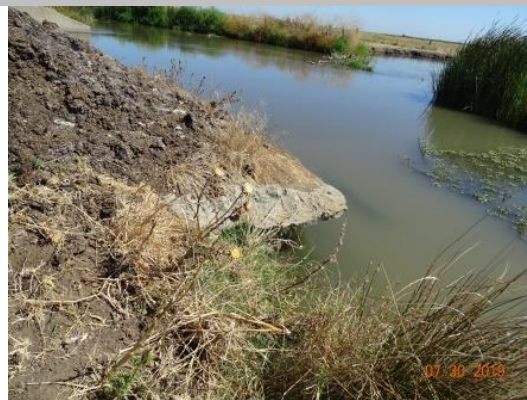
Photo 1 of 2 : ST_2019_NA0010_34_4_20190802_00021.jpg

LM Start	0.00	Rating **	M	Issue No.	4
LM End	0.00	Issue Type +	Ma	Location *	
Category	Structures & Concrete Lined Channels			GPS Latitude/Longitude	
				Start	End
Item	Erosion / Bank Caving			37.254970 °	37.254970 °
				-120.718450 °	-120.718450 °
DWR ID	DWR_NA0010_34_t_2012_4				
Action/Comments					
Inspector Comments: Erosion at upstream left bank undermining an area of concrete revetment.

View of erosion at left bank on the upstream side of the structure. (2019)

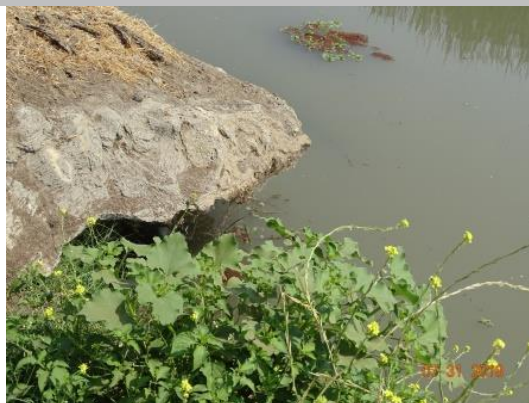
Photo 2 of 2 : ST_2019_NA0010_34_4_20190613_00005.jpg

LM Start	0.00	Rating **	M	Issue No.	4 (cont)	
LM End	0.00	Issue Type +	Ma	Location *		
Category	Structures & Concrete Lined Channels			GPS Latitude/Longitude		
				Start	End	
Item	Erosion / Bank Caving			37.254970 °	37.254970 °	
				-120.718450 °	-120.718450 °	
DWR ID	DWR_NA0010_34_t_2012_4					
Action/Comments						
Inspector Comments: Erosion at upstream left bank undermining an area of concrete revetment.

Close up of erosion at upstream left bank. (2018)

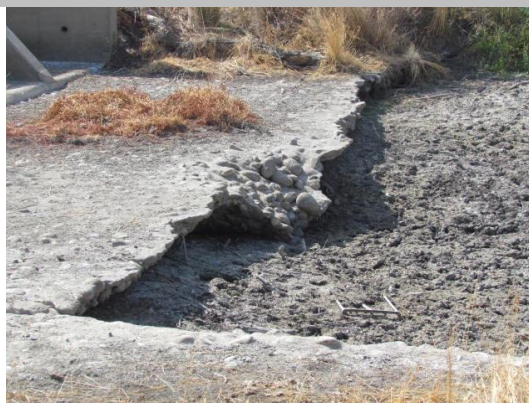
Photo 1 of 3 : ST_2019_NA0010_34_5_20190613_00006.jpg

LM Start	0.00	Rating **	M	Issue No.	5
LM End	0.00	Issue Type +	Ma	Location *	
Category	Structures & Concrete Lined Channels			GPS Latitude/Longitude	
				Start	End
Item	Revetments			37.254970 °	37.254970 °
				-120.718450 °	-120.718450 °
DWR ID	DWR_NA0010_34_t_2012_5				
Action/Comments					
Inspector Comments: Some minor revetment scouring on downstream side of structure was identified in previous inspections. Scour was not visible during 2019 inspection.

Looking at minor revetment erosion on downstream side of structure. (2015)

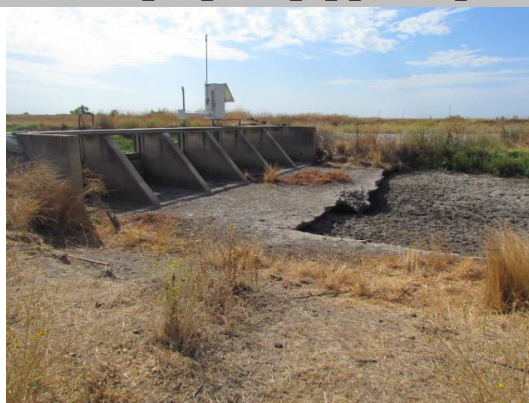
Photo 2 of 3 : ST_2019_NA0010_34_5_20190613_00007.jpg

Looking at revetments on downstream side of structure. (2015)

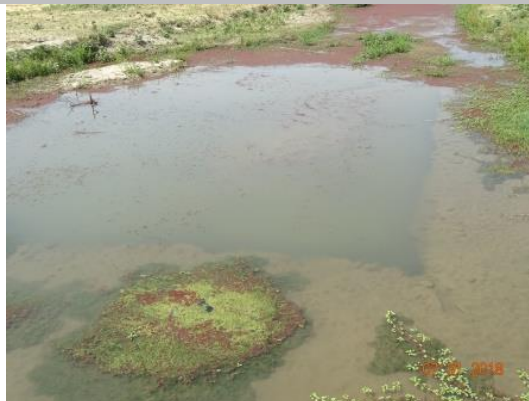
Photo 3 of 3 : ST_2019_NA0010_34_5_20190613_00008.jpg

LM Start	0.00	Rating **	M	Issue No.	5 (cont)	
LM End	0.00	Issue Type +	Ma	Location *		
Category	Structures & Concrete Lined Channels			GPS Latitude/Longitude		
				Start		End
Item	Revetments			37.254970 °		37.254970 °
				-120.718450 °		-120.718450 °
DWR ID	DWR_NA0010_34_t_2012_5					
Action/Comments						
Inspector Comments: Some minor revetment scouring on downstream side of structure was identified in previous inspections. Scour was not visible during 2019 inspection.

Revetment erosion on downstream side of structure. (2018)

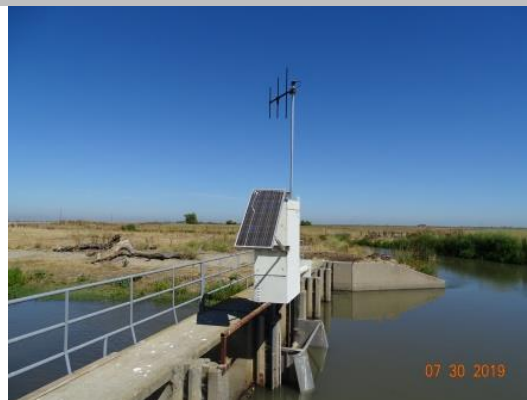
Photo 1 of 2 : ST_2019_NA0010_34_13_20190802_00022.jpg

LM Start	0.00	Rating **	A	Issue No.	13
LM End	0.00	Issue Type +	Ma	Location *	
Category	Structures & Concrete Lined Channels	GPS Latitude/Longitude			
		Start	End		
Item	Electric Gate Operators	37.254970 °		37.254970 °	
		-120.718450 °		-120.718450 °	
DWR ID	DWR_NA0010_34_t_2012_13				
Action/Comments					
Inspector Comments: Electric gate appears to be properly maintained and is in good working condition.

Looking at gate operator on upstream side of structure. (2019)

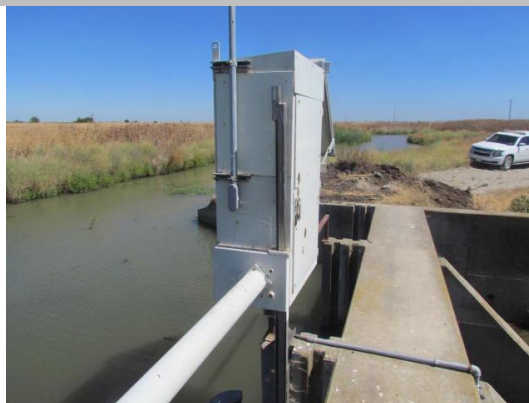
Photo 2 of 2 : ST_2019_NA0010_34_13_20190613_00010.jpg

LM Start	0.00	Rating **	A	Issue No.	13 (cont)
LM End	0.00	Issue Type +	Ma	Location *	
Category	Structures & Concrete Lined Channels			GPS Latitude/Longitude	
				Start	End
Item	Electric Gate Operators			37.254970 °	37.254970 °
				-120.718450 °	-120.718450 °
DWR ID	DWR_NA0010_34_t_2012_13				
Action/Comments					
Inspector Comments: Electric gate appears to be properly maintained and is in good working condition.

Looking at electrical control panel on east side of structure. (2017)

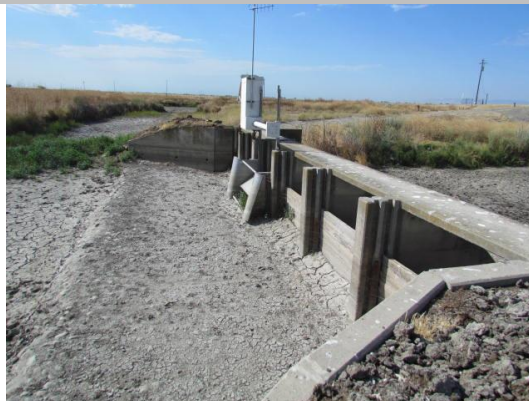
Photo 1 of 3 : ST_2019_NA0010_34_17_20190613_00014.jpg

LM Start	0.00	Rating **	A	Issue No.	17
LM End	0.00	Issue Type +	Ma	Location *	
Category	Structures & Concrete Lined Channels			GPS Latitude/Longitude	
				Start	End
Item	Concrete Foundations			37.254970 °	37.254970 °
				-120.718450 °	-120.718450 °
DWR ID	DWR_NA0010_34_t_2012_17				
Action/Comments					
Inspector Comments: No visible erosion near foundation. Unable to view full area due to water level. (2019)

Looking at upstream side of structure.

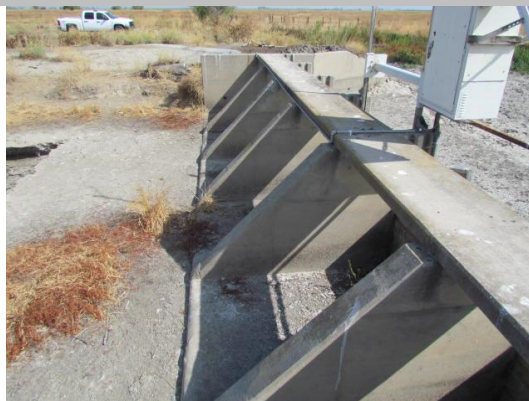
Photo 2 of 3 : ST_2019_NA0010_34_17_20190613_00015.jpg

Looking at downstream side of structure.

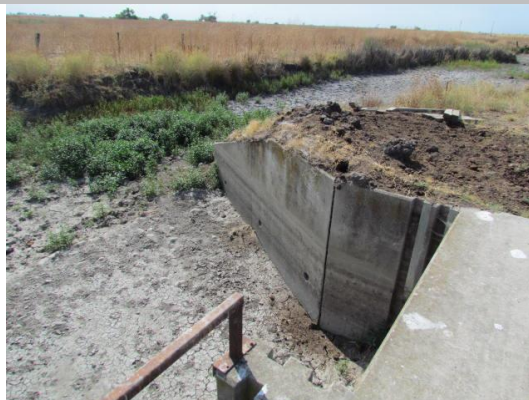
Photo 3 of 3 : ST_2019_NA0010_34_17_20190613_00016.jpg

Looking at left wing wall on upstream side of structure.

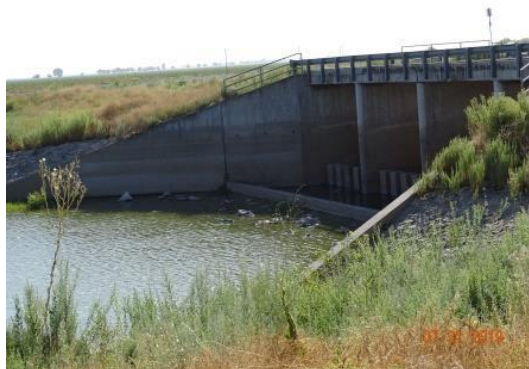
Photo 1 of 3 : ST_2019_NA0010_65_1_20190806_00010.jpg

LM Start	0.00	Rating **	N	Issue No.	1
LM End	0.00	Issue Type +	Ma	Location *	
Category	Structures & Concrete Lined Channels			GPS Latitude/Longitude	
				Start	End
Item	Photo Documentation			36.774021 °	36.774021 °
				-120.284476 °	-120.284476 °
DWR ID	DWR_NA0010_65_t_2017_1				
Action/Comments					
Inspector Comments: Structure appears to be properly maintained.

View of downstream side of structure. (2019)

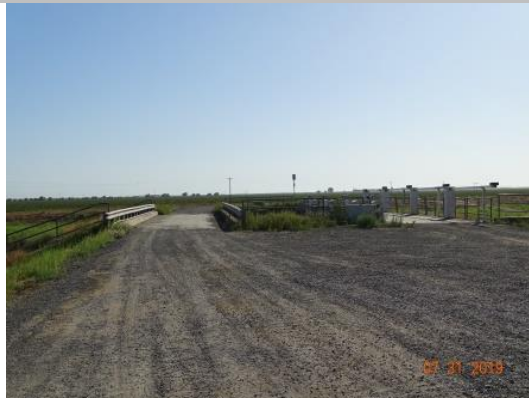
Photo 2 of 3 : ST_2019_NA0010_65_1_20190806_00011.jpg

View of the top of the structure from the left bank. (2019)

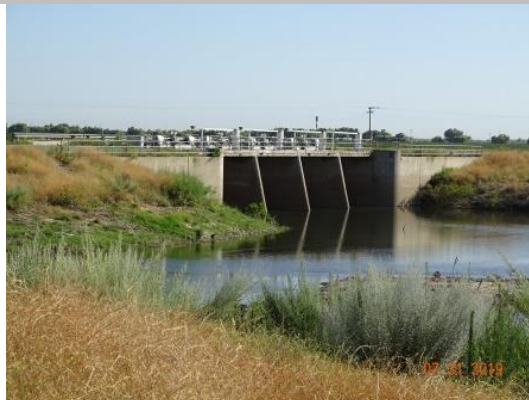
Photo 3 of 3 : ST_2019_NA0010_65_1_20190806_00012.jpg

View of upstream side of the structure. (2019)

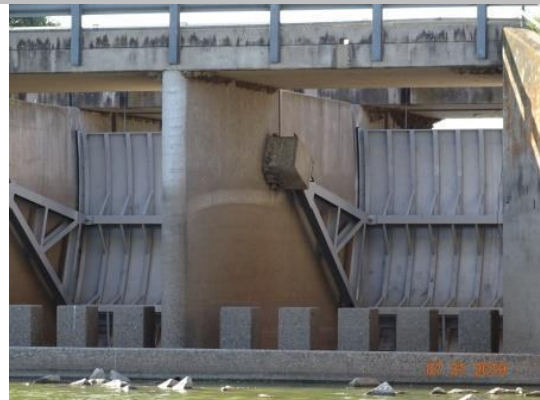
Photo 1 of 1 : ST_2019_NA0010_65_7_20190806_00013.jpg

LM Start	0.00	Rating **	A	Issue No.	7
LM End	0.00	Issue Type +	Ma	Location *	
Category	Structures & Concrete Lined Channels	GPS Latitude/Longitude			
		Start		End	
Item	Culverts: Inlets / Outlets	36.774021 °		36.774021 °	
		-120.284476 °		-120.284476 °	
DWR ID	DWR_NA0010_65_t_2017_7				
Action/Comments					
Inspector Comments: No obstructions identified in inlets and outlets.

View of structure outlets. (2019)

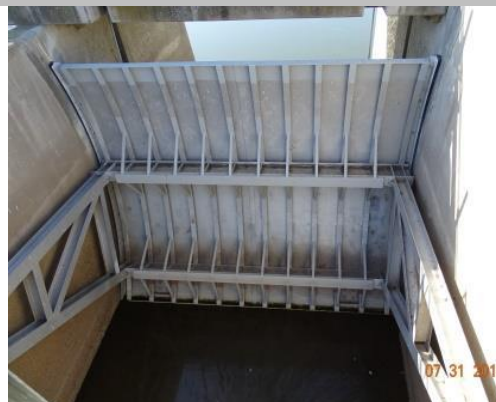
Photo 1 of 1 : ST_2019_NA0010_65_12_20190806_00014.jpg

LM Start	0.00	Rating **	A	Issue No.	12
LM End	0.00	Issue Type +	Ma	Location *	
Category	Structures & Concrete Lined Channels	GPS Latitude/Longitude			
		Start		End	
Item	Sluice/Slide Gates	36.774021 °		36.774021 °	
		-120.284476 °		-120.284476 °	
DWR ID	DWR_NA0010_65_t_2017_12				
Action/Comments					
Inspector Comments: Gates are operable and appear to be well maintained.

Representative picture of the gates. (2019)

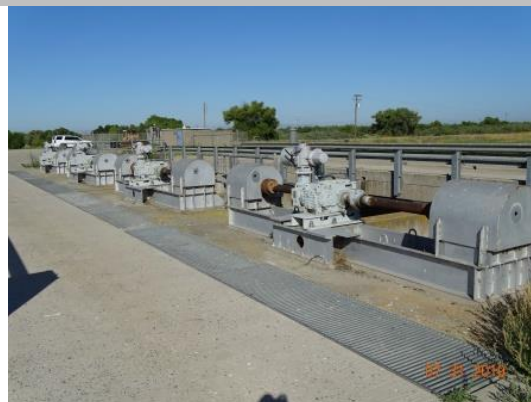
Photo 1 of 2 : ST_2019_NA0010_65_13_20190806_00015.jpg

LM Start	0.00	Rating **	A	Issue No.	13
LM End	0.00	Issue Type +	Ma	Location *	
Category	Structures & Concrete Lined Channels	GPS Latitude/Longitude			
		Start		End	
Item	Electric Gate Operators	36.774021 °		36.774021 °	
		-120.284476 °		-120.284476 °	
DWR ID	DWR_NA0010_65_t_2017_13				
Action/Comments					
Inspector Comments: Electric gate operators appear to be in good working condition.

View of electric gate operators. (2019)

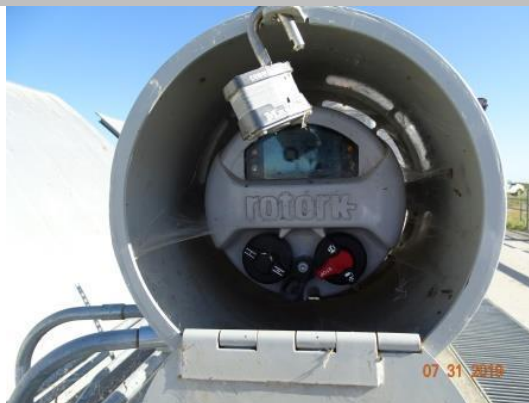
Photo 2 of 2 : ST_2019_NA0010_65_13_20190806_00017.jpg

LM Start	0.00	Rating **	A	Issue No.	13 (cont)	
LM End	0.00	Issue Type +	Ma	Location *		
Category	Structures & Concrete Lined Channels			GPS Latitude/Longitude		
				Start	End	
Item	Electric Gate Operators			36.774021 °	36.774021 °	
				-120.284476 °	-120.284476 °	
DWR ID	DWR_NA0010_65_t_2017_13					
Action/Comments						
Inspector Comments: Electric gate operators appear to be in good working condition.

Representative view of electric gate controls. (2019)

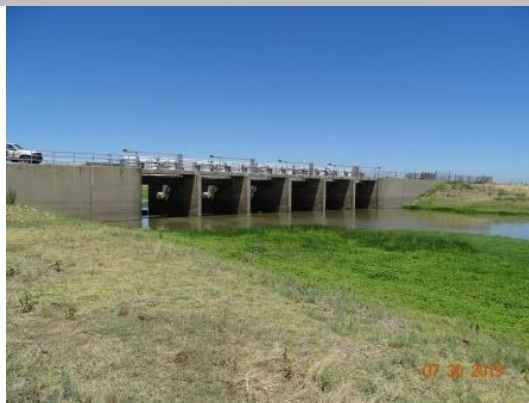
Photo 1 of 3 : ST_2019_NA0010_43_1_20190805_00015.jpg

View of the upstream side of the structure. (2019)

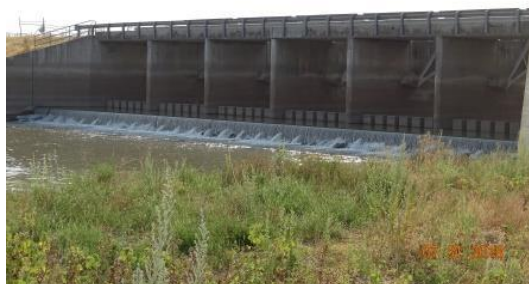
Photo 2 of 3 : ST_2019_NA0010_43_1_20190613_00002.jpg

View of the downstream side of the structure. (2018)

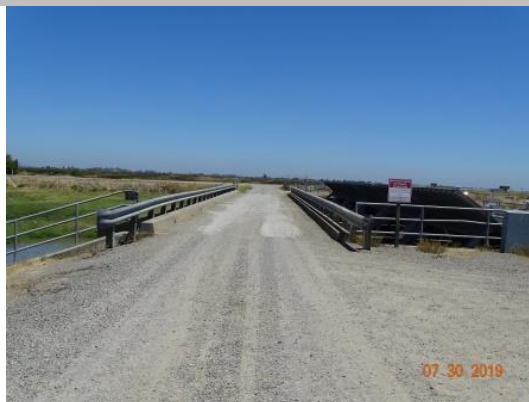
Photo 3 of 3 : ST_2019_NA0010_43_1_20190805_00014.jpg

View across the top of the structure from the left bank. (2019)

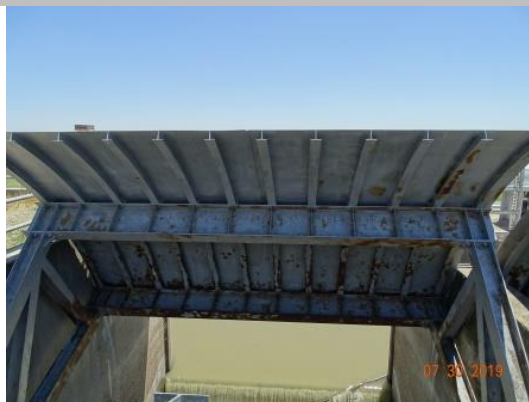
Photo 1 of 3 : ST_2019_NA0010_43_12_20190805_00016.jpg

Looking at typical view of control gate. (2019)

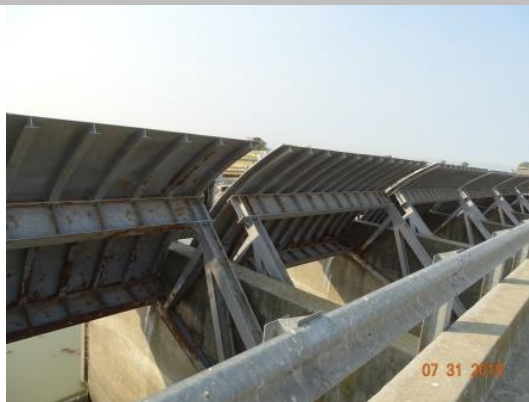
Photo 2 of 3 : ST_2019_NA0010_43_12_20190613_00005.jpg

View of control gates. (2018)

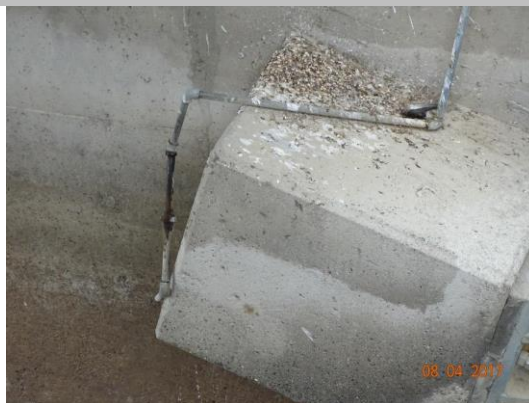
Photo 3 of 3 : ST_2019_NA0010_43_12_20190613_00007.jpg

LM Start	0.00	Rating **	A	Issue No.	12 (cont)	
LM End	0.00	Issue Type +	Ma	Location *		
Category	Structures & Concrete Lined Channels			GPS Latitude/Longitude		
				Start		End
Item	Sluice/Slide Gates			37.204867 °		37.204867 °
				-120.696985 °		-120.696985 °
DWR ID	DWR_NA0010_43_t_2012_12					
Action/Comments						
Inspector Comments: Item appears to be adequately maintained and able to perform as intended. At least one grease fitting is not connected to hinge point on gate.

View of grease point that is not connected. (2017)

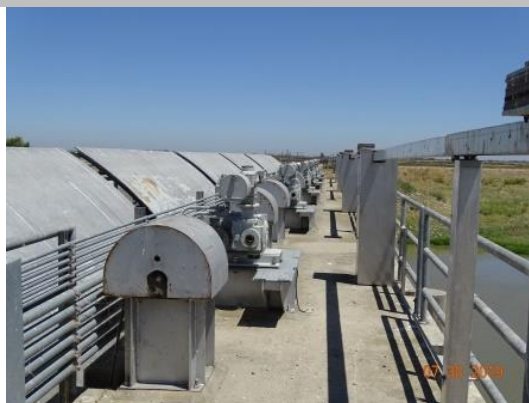
Photo 1 of 3 : ST_2019_NA0010_43_13_20190805_00017.jpg

LM Start	0.00	Rating **	A	Issue No.	13
LM End	0.00	Issue Type +	Ma	Location *	
Category	Structures & Concrete Lined Channels	GPS Latitude/Longitude			
		Start		End	
Item	Electric Gate Operators	37.204867 °		37.204867 °	
		-120.696985 °		-120.696985 °	
DWR ID	DWR_NA0010_43_t_2012_13				
Action/Comments					
Inspector Comments: Gate operators perform as intended and appear to be adequately maintained.

View of electric gate motors. (2019)

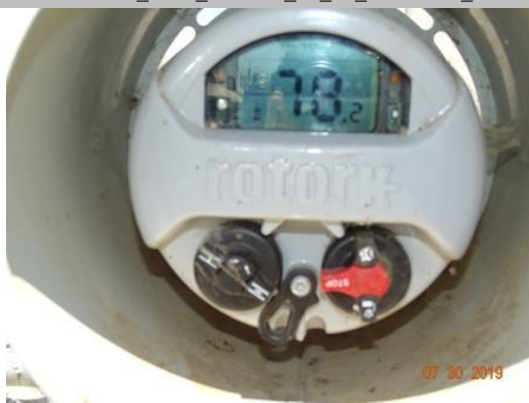
Photo 2 of 3 : ST_2019_NA0010_43_13_20190806_00023.jpg

Typical view of electric gate controls. (2019)

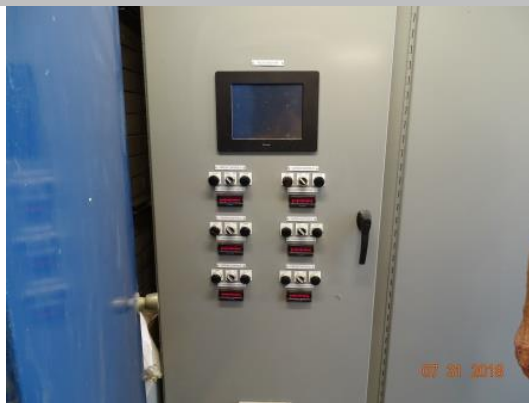
Photo 3 of 3 : ST_2019_NA0010_43_13_20190613_00009.jpg

LM Start	0.00	Rating **	A	Issue No.	13 (cont)	
LM End	0.00	Issue Type +	Ma	Location *		
Category	Structures & Concrete Lined Channels			GPS Latitude/Longitude		
				Start	End	
Item	Electric Gate Operators			37.204867 °	37.204867 °	
				-120.696985 °	-120.696985 °	
DWR ID	DWR_NA0010_43_t_2012_13					
Action/Comments						
Inspector Comments: Gate operators perform as intended and appear to be adequately maintained.

View of control panel. (2018)

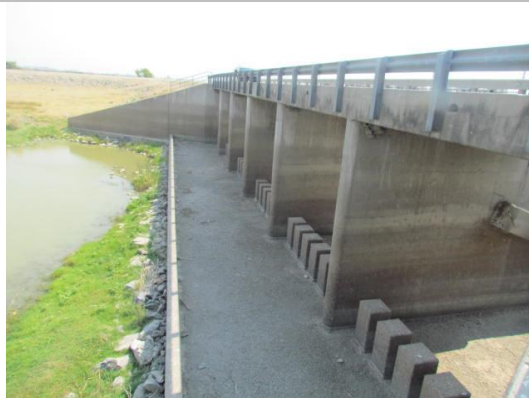
Photo 1 of 2 : ST_2019_NA0010_43_17_20190613_00010.jpg

LM Start	0.00	Rating **	A	Issue No.	17
LM End	0.00	Issue Type +	Ma	Location *	
Category	Structures & Concrete Lined Channels	GPS Latitude/Longitude			
		Start		End	
Item	Concrete Foundations	37.204867 °		37.204867 °	
		-120.696985 °		-120.696985 °	
DWR ID	DWR_NA0010_43_t_2012_17				
Action/Comments					
Inspector Comments: No visible erosion near foundation, unable to view full area due to water levels.

Looking at downstream side of structure. (2017)

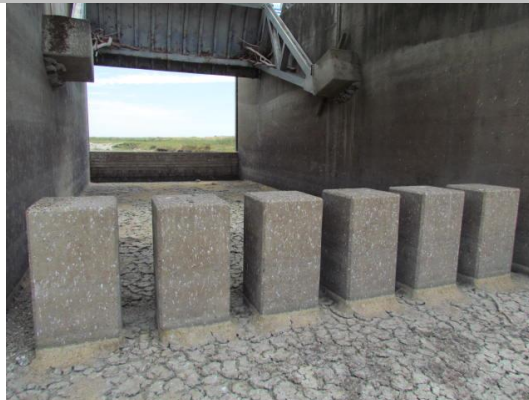
Photo 2 of 2 : ST_2019_NA0010_43_17_20190613_00011.jpg

Looking at typical of control structure bay. (2017)

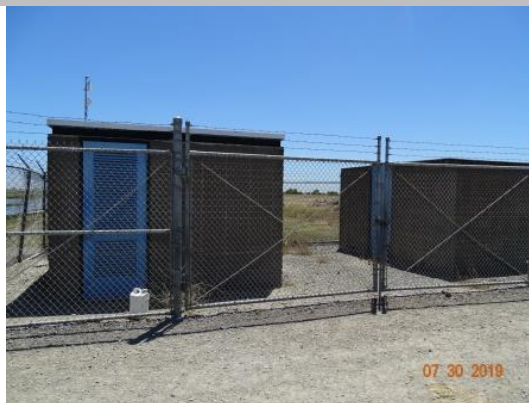
Photo 1 of 1 : ST_2019_NA0010_43_18_20190805_00018.jpg

LM Start	0.00	Rating **	A	Issue No.	18
LM End	0.00	Issue Type +	Ma	Location *	
Category	Structures & Concrete Lined Channels			GPS Latitude/Longitude	
				Start	End
Item	Security Fencing			37.204867 °	37.204867 °
				-120.696985 °	-120.696985 °
DWR ID	DWR_NA0010_43_t_2012_18				
Action/Comments					
Inspector Comments: Security fencing around electrical house is in good condition.

View of security fencing around electrical housing. (2019)

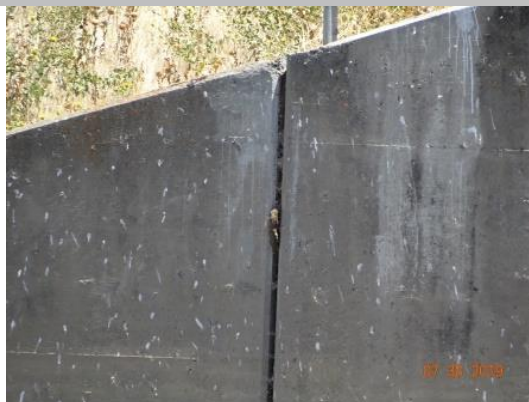
Photo 1 of 2 : ST_2019_NA0010_43_22_20190805_00021.jpg

LM Start	0.00	Rating **	A	Issue No.	22
LM End	0.00	Issue Type +	Ma	Location *	
Category	Structures & Concrete Lined Channels	GPS Latitude/Longitude			
		Start		End	
Item	Monolith Joints	37.204867 °		37.204867 °	
		-120.696985 °		-120.696985 °	
DWR ID	DWR_NA0010_43_t_2012_22				
Action/Comments					
Inspector Comments: Minor joint deterioration at wingwalls.

View of monolith joint at right wingwall. (2019)

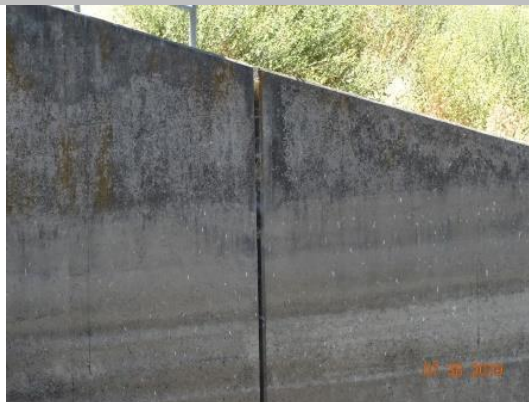
Photo 2 of 2 : ST_2019_NA0010_43_22_20190805_00022.jpg

View of monolith joint at left wingwall. (2019)

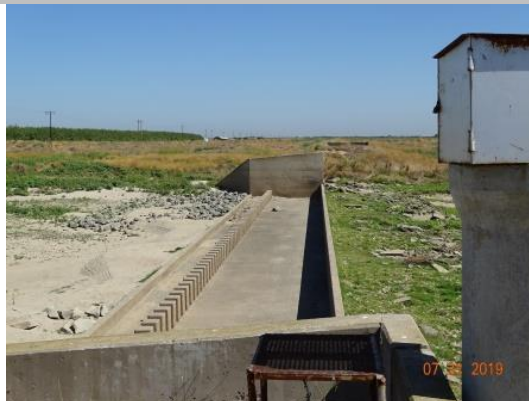
Photo 1 of 3 : ST_2019_NA0010_29_1_20190806_00022.jpg

Overview of structure from the left bank. (2019)

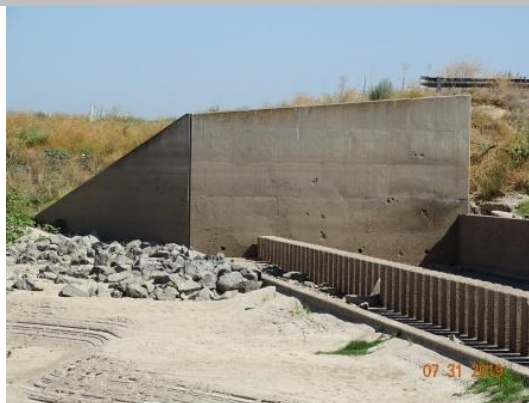
Photo 2 of 3 : ST_2019_NA0010_29_1_20190806_00019.jpg

View of right wing wall. (2019)

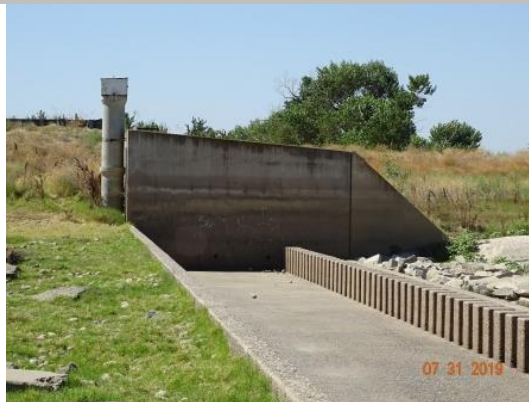
Photo 3 of 3 : ST_2019_NA0010_29_1_20190806_00021.jpg

View of left wing wall. (2019)

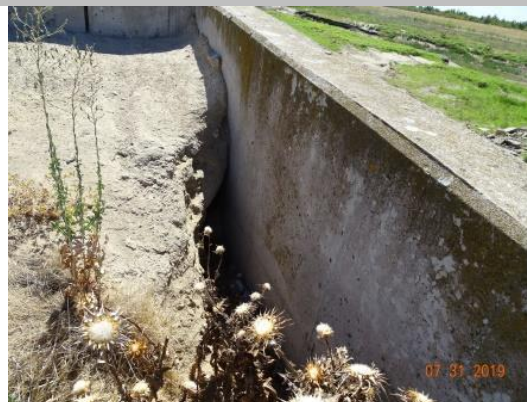
Photo 1 of 3 : ST_2019_NA0010_29_4_20190807_00023.jpg

LM Start	0.00	Rating **	M	Issue No.	4
LM End	0.00	Issue Type +	Ma	Location *	
Category	Structures & Concrete Lined Channels	GPS Latitude/Longitude			
		Start		End	
Item	Erosion / Bank Caving	36.975666 °		36.975666 °	
		-120.382143 °		-120.382143 °	
DWR ID	DWR_NA0010_29_t_2012_4				
Action/Comments					
Inspector Comments: Some caving on right wing wall(north side)

View of erosion/caving on right wing wall. (2019)

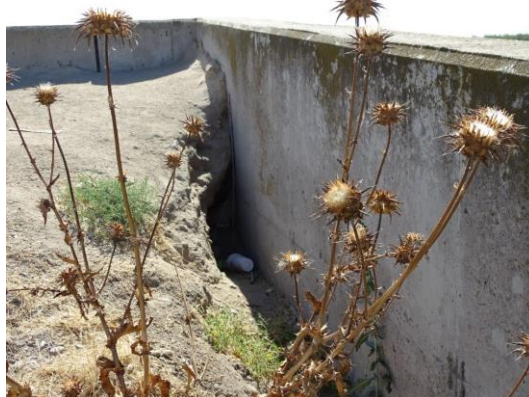
Photo 2 of 3 : ST_2019_NA0010_29_4_20190613_00006.jpg

LM Start	0.00	Rating **	M	Issue No.	4 (cont)	
LM End	0.00	Issue Type +	Ma	Location *		
Category	Structures & Concrete Lined Channels			GPS Latitude/Longitude		
				Start		End
Item	Erosion / Bank Caving			36.975666 °	36.975666 °	
				-120.382143 °	-120.382143 °	
DWR ID	DWR_NA0010_29_t_2012_4					
Action/Comments						
Inspector Comments: Some caving on right wing wall(north side)

View of erosion/caving on right wing wall (North side) (Summer 2017)

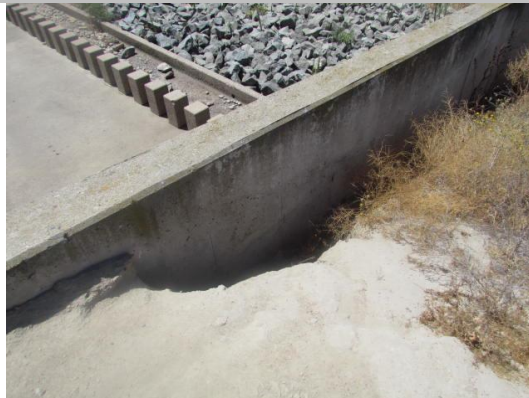
Photo 3 of 3 : ST_2019_NA0010_29_4_20190613_00009.jpg

Looking at erosion/caving on right wing wall on summer 2014.

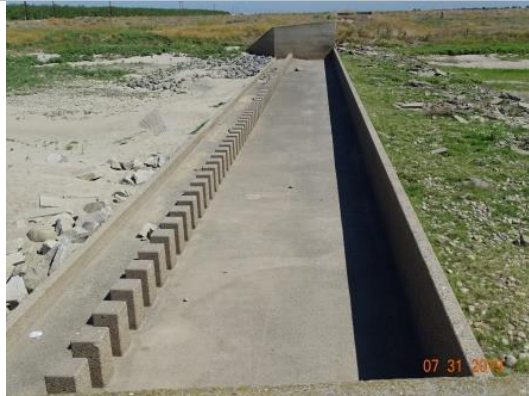
Photo 1 of 2 : ST_2019_NA0010_29_5_20190807_00026.jpg

LM Start	0.00	Rating **	A	Issue No.	5	
LM End	0.00	Issue Type +	Ma	Location *		
Category	Structures & Concrete Lined Channels			GPS Latitude/Longitude		
				Start	End	
Item	Revetments			36.975666 °	36.975666 °	
				-120.382143 °	-120.382143 °	
DWR ID	DWR_NA0010_29_t_2012_5					
Action/Comments						
Inspector Comments: Item appears to be acceptably maintained

View of revetment looking towards right wing wall. (2019)

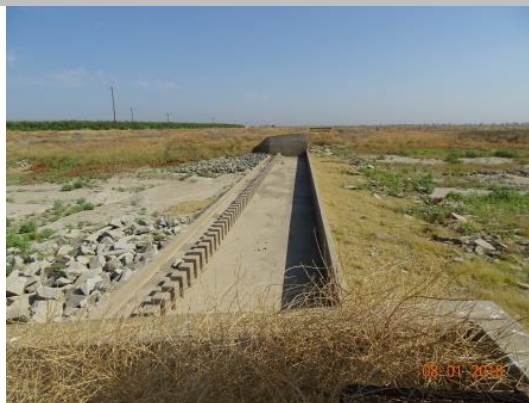
Photo 2 of 2 : ST_2019_NA0010_29_5_20190613_00010.jpg

LM Start	0.00	Rating **	A	Issue No.	5 (cont)	
LM End	0.00	Issue Type +	Ma	Location *		
Category	Structures & Concrete Lined Channels			GPS Latitude/Longitude		
				Start		End
Item	Revetments			36.975666 °		36.975666 °
				-120.382143 °		-120.382143 °
DWR ID	DWR_NA0010_29_t_2012_5					
Action/Comments						
Inspector Comments: Item appears to be acceptably maintained

View of revetment looking towards right wing wall. (2018)

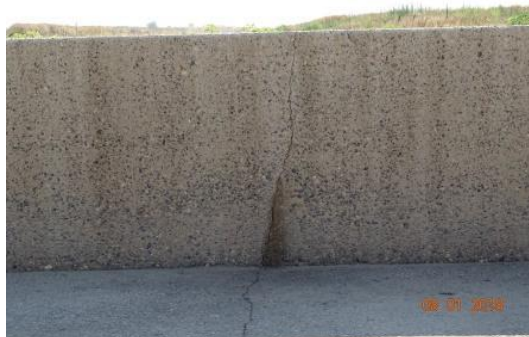
Photo 3 of 3 : ST_2019_NA0010_29_15_20190613_00014.jpg

LM Start	0.00	Rating **	A	Issue No.	15 (cont)	
LM End	0.00	Issue Type +	Ma	Location *		
Category	Structures & Concrete Lined Channels			GPS Latitude/Longitude		
				Start		End
Item	Concrete Surfaces			36.975666 °		36.975666 °
				-120.382143 °		-120.382143 °
DWR ID	DWR_NA0010_29_t_2012_15					
Action/Comments						
Inspector Comments: Negligible spalling present on both wing walls. Small crack at head wall.

Small crack at head wall. (2018)

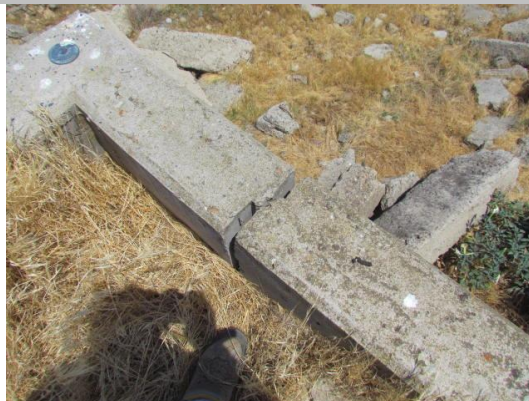
Photo 3 of 4 : ST_2019_NA0010_29_22_20190613_00017.jpg

LM Start	0.00	Rating **	M	Issue No.	22 (cont)
LM End	0.00	Issue Type +	Ma	Location *	
Category	Structures & Concrete Lined Channels			GPS Latitude/Longitude	
				Start	End
Item	Monolith Joints			36.975666 °	36.975666 °
				-120.382143 °	-120.382143 °
DWR ID	DWR_NA0010_29_t_2012_22				
Action/Comments					
Inspector Comments: Some minor movement and rubber seal missing at the wing wall joint on south wingwall.

Looking at top view of right wing wall. (2017)

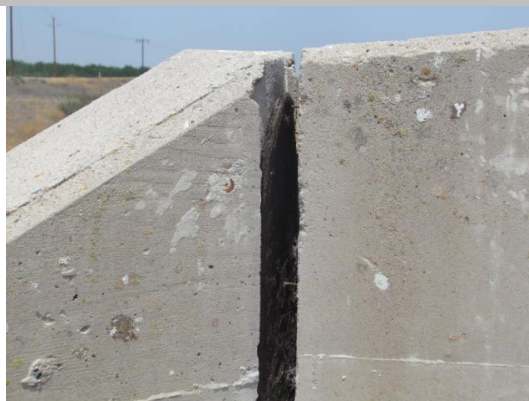
Photo 4 of 4 : ST_2019_NA0010_29_22_20190613_00018.jpg

Looking at right wing wall. (2017)
